Mandatory Service Bulletin
No. MSB-E4-026/1

MANDATORY SERVICE BULLETIN

Inspection of Engine Harness

Engine type: E4
Engine model(s): E4, E4P
Serial number(s): E4-A-00001 through E4-A-00539
E4-B-00001 through E4-B-00554
E4-C-00001 through E4-C-00539
E4P-C-00001 through E4P-C-00229

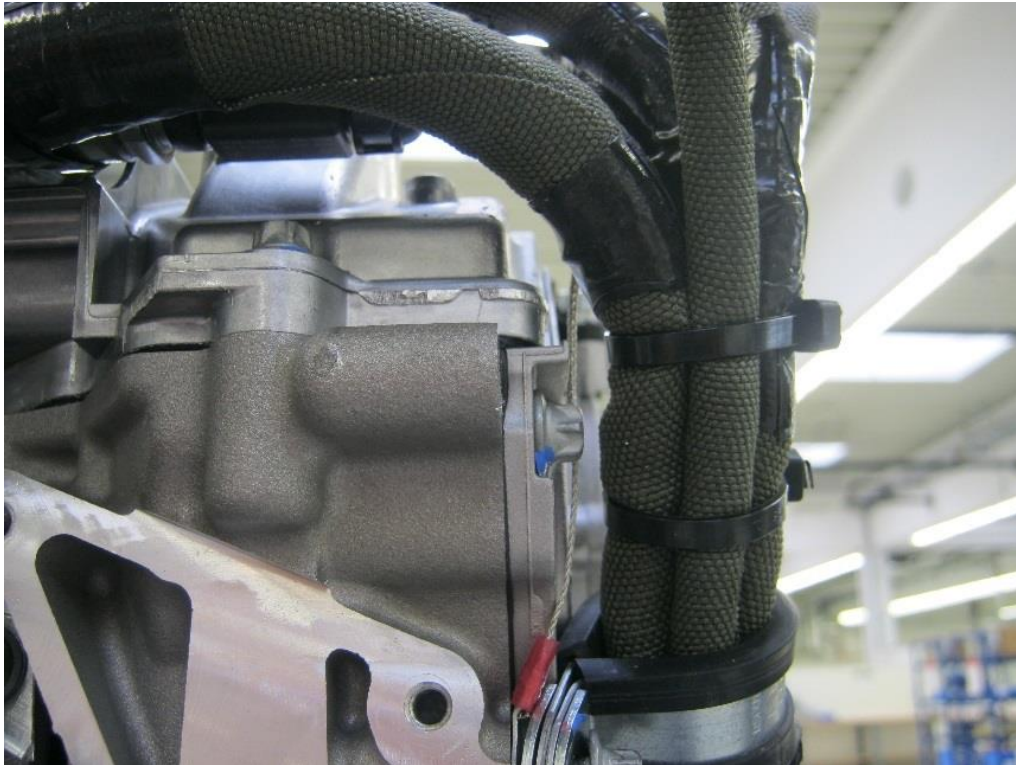
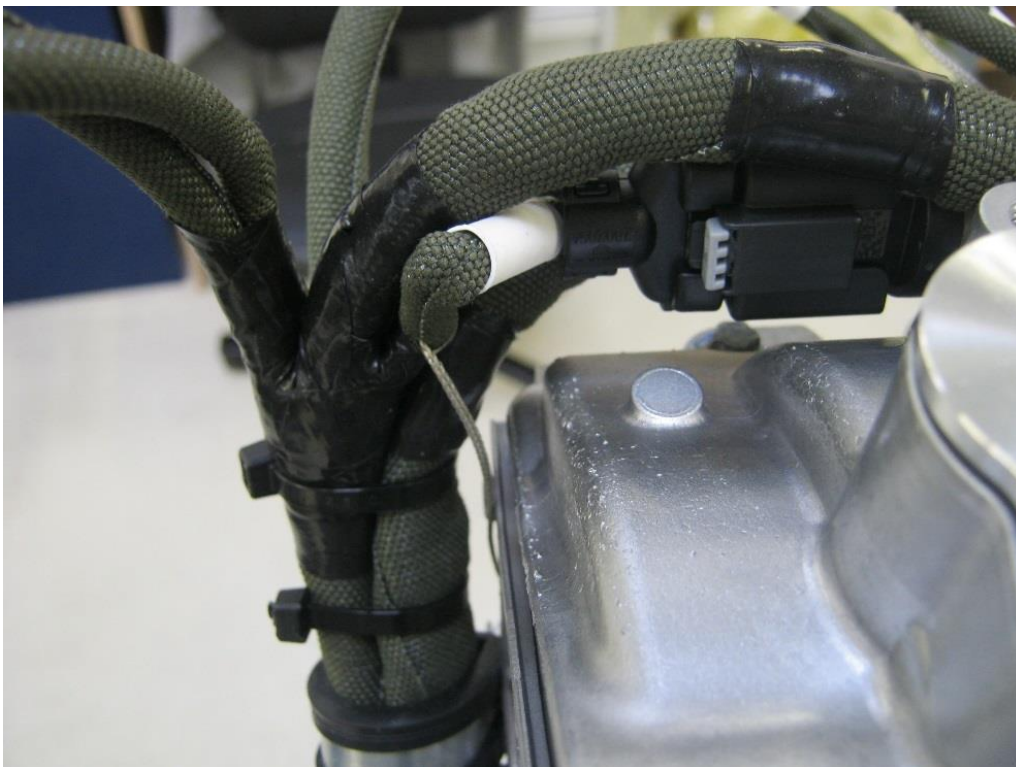
3. If the engine harness has a black rubbery surface, proceed with step 10. Otherwise (if the engine harness has a green fabric surface) proceed with step 4.
4. Make sure there is sufficient clearance between the wiring harness and the cylinder head. Refer to Figure 1 and Figure 2 for examples of acceptable clearance.

Insufficient clearance can lead to chaffing of the engine harness on the engine.

- Make yourself familiar with the routing instructions for the engine harness in Maintenance Manual Section 71-50-03, before you follow the instructions of this Service Bulletin.
- If the inspection results in findings, install the affected sections of the engine harness according to Maintenance Manual Section 71-50-170.
- Install additional cable ties as necessary to attach the engine harness properly.

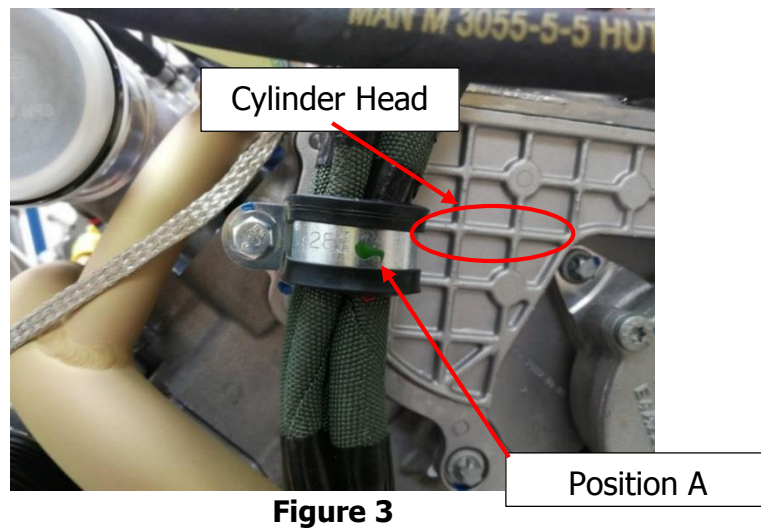
Figure 3

- Step not applicable for E4-A engines: The attached cable clamp is parallel to the fins of the engine head (refer to Figure 3).
- Step not applicable for E4-A engines: The cable clamp fully (A) covers the red tape on the harness (refer to Figure 4).
- The red sleeve (B) is approximately aligned with the rail pressure sensor (RPS) connector (refer to Figure 4).

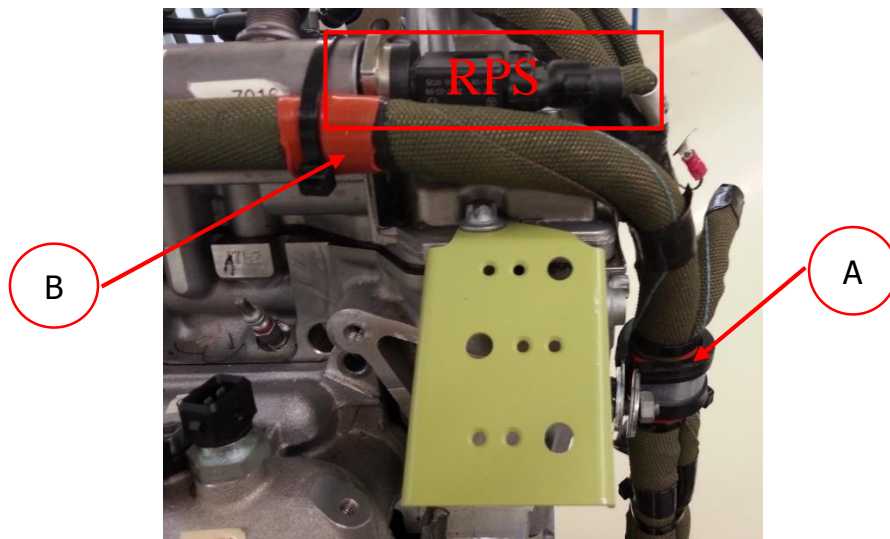
Figure 4

- As installation aid a red tape is wrapped over the three parallel routed wiring harness branches at the belt drive side of the engine and a red sleeve is on the engine harness branch, that is attached to the fuel rail (refer to Figure 4).

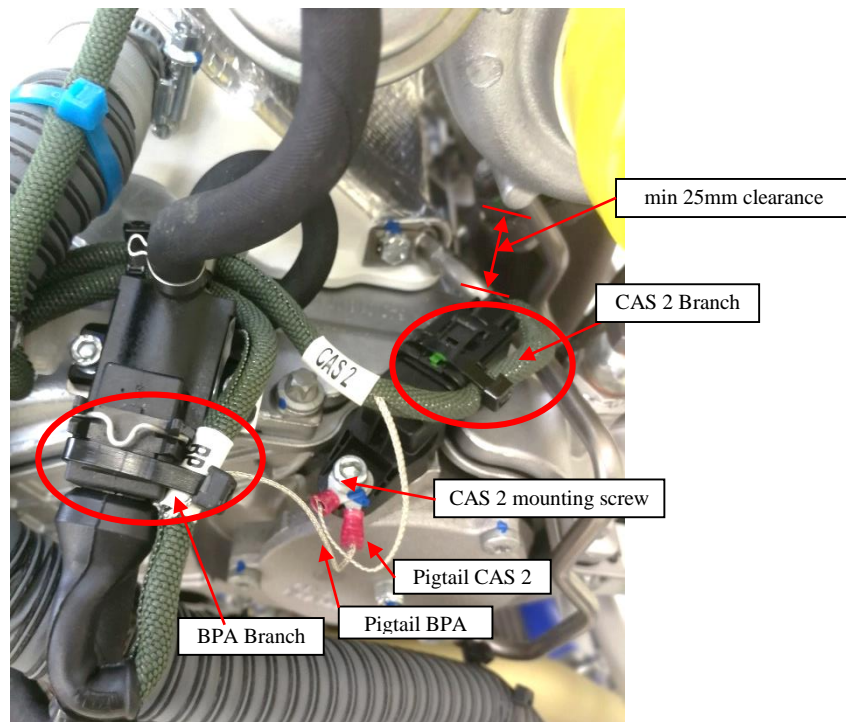
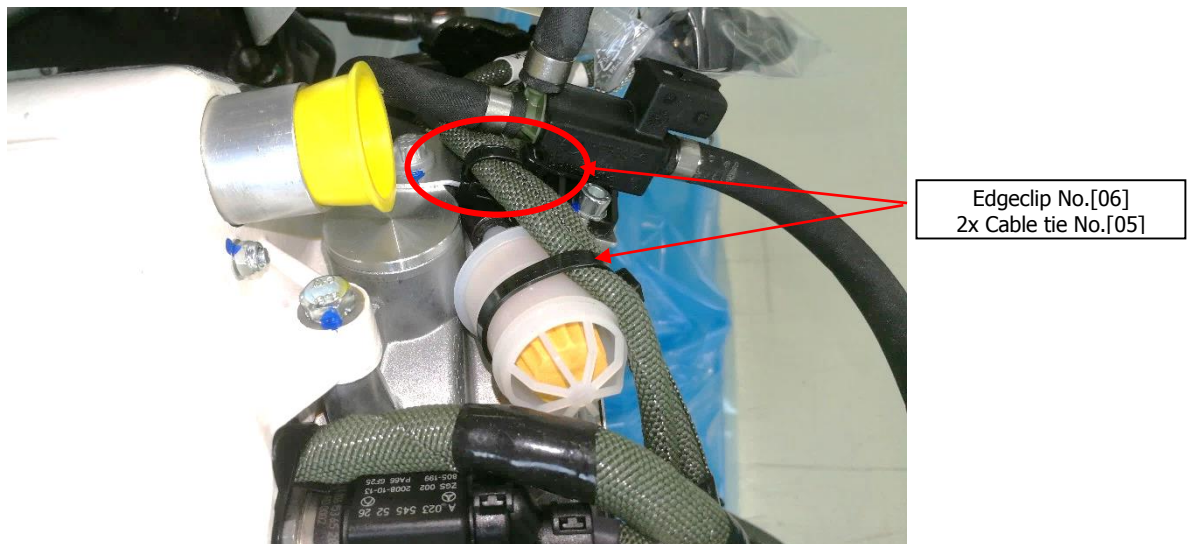
5. Examine the BPA and the CAS 2 Branch for correct installation. Refer to Figure 5.

- The BPA and CAS 2 Branch are attached to the boost pressure actuator BPA and the camshaft angle sensor CAS 2 with cable ties and edge clips to the BPA bracket (see Figure 5 and Figure 6).
- The cable ties do not unlock the BPA and CAS 2 harness connectors.
- The clearance between the engine harness and the turbocharger is more than 25 mm (1 inch.)
- The BPA filter is attached with a cable tie (see Figure 6).
- The connector adapter (of BPA filter) is used for fixation with the cable tie.
- The cable tie does not press on the BPA hose so tight, that the hose is blocked.

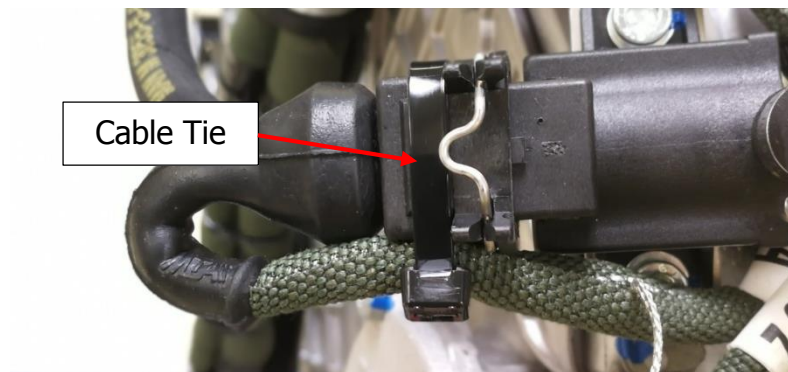
Figure 7

- The bending radii of the harness branches are sufficiently large. Refer Maintenance Manual Section 71-50-03.
- The harness branches are attached to the connector with a cable tie.
- The cable tie does not unlock the harness connector.
- The BPA branch is attached with a cable tie on the BPA connector housing as shown in Figure 7.

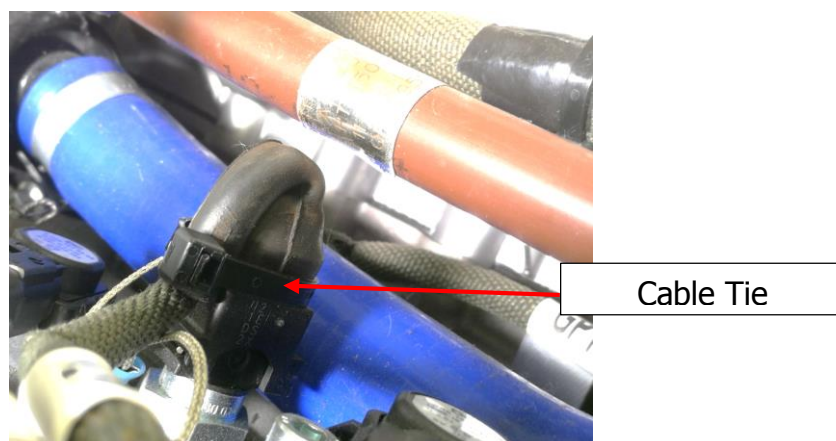
Figure 8

Make sure that the cable is attached with cable tie on the connector of the sensors as shown in Figure 8.

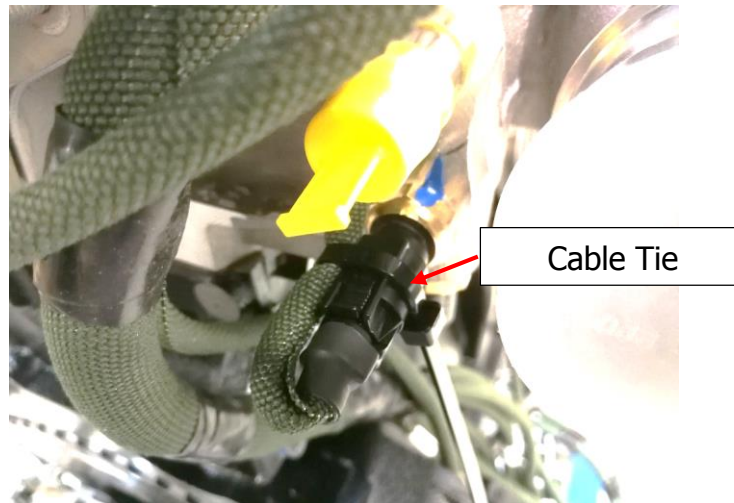
Figure 9

Make sure that the cable is attached with cable tie directly to CTS connector as shown in Figure 9.

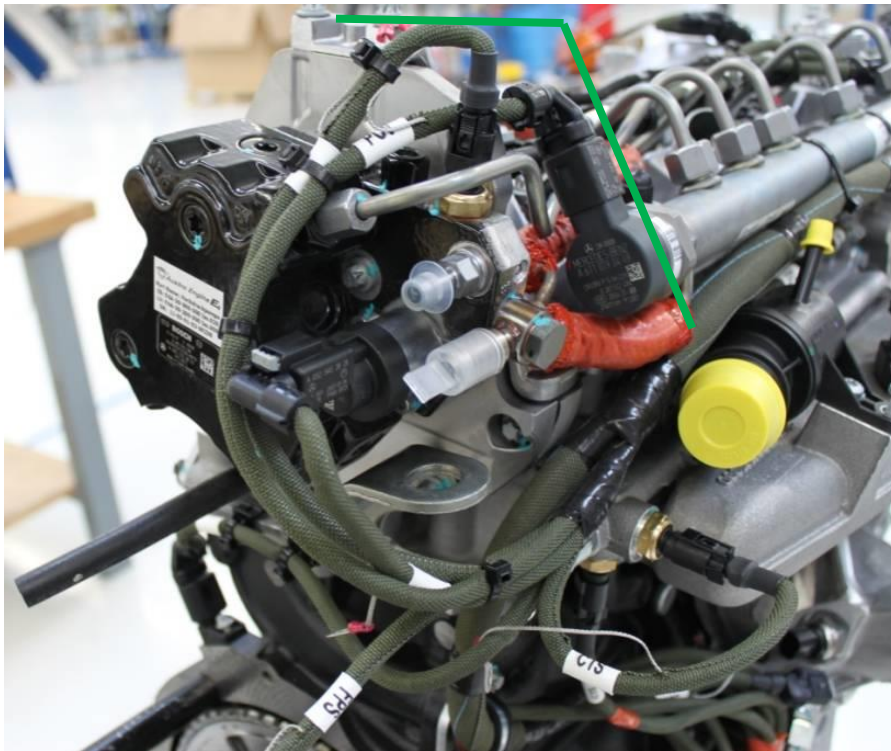
Figure 10

- The engine wiring branch is attached as shown in Figure 10.
- The cable branches are attached with cable ties.
- The harness branches run as long as possible parallel to each other.
- The harness branches do not cross each other, if it is not necessary for connecting to the respective connector.
- The wires do not go over the green marked line (see Figure 10).

If cables go over the green marked line, they can interfere with the aircraft installation.
